Second Floor Plan, Pre-restoration

#### ROOM 201 VESTIBULE TO BALCONY

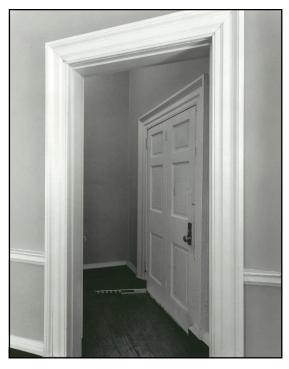
Room 201 Vestibule to Balcony

*Floor*: The stained and varnished floor consists of random-width, tongue-and-groove boards,  $3 \frac{1}{2}$ " to 5," which run north-south. Boards are continuous between Rooms 201 and 202, and are not interrupted or covered by any threshold at the doorway between them.

*Ceiling*: The ceiling is plaster and paint on wood lath.

*Walls:* The east wall consists of plaster and paint on brick while the west, south and north walls consist of plaster and paint on lath attached to wood studs.

*Baseboards:* On the east wall, the baseboard [Type B15] is the same as the east wall of Room 203: a 5  $\frac{3}{4}$ " vertical face painted black with a 2  $\frac{1}{4}$ " molded top painted white and no floor molding. The north, west and south baseboards [Type B-14] are 8  $\frac{3}{4}$ " with a 6  $\frac{1}{2}$ " vertical face painted black and 2  $\frac{1}{4}$ " molded top painted white. The east wall molding appears to be older than that of the other walls.

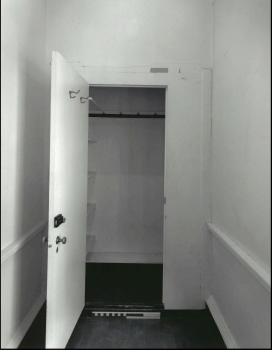
Dressing room 202 A, looking toward Closet 202 B

*Floor:* The stained and varnished floor consists of 5" tongue-and-groove boards running north-south.

*Ceiling:* The ceiling consists of plaster on wood lath with one light fixture roughly mounted in the center of the ceiling.

*Walls:* The east wall, which consists of plaster and paint on brick masonry, has signs of diagonal hairline cracking. The north wall is painted wallboard, which is delaminating. The south and west walls are plaster on wood lath attached to wood studs.

*Baseboard:* The 8  $\frac{1}{2}$ " baseboards consist of a 6" vertical face painted black with a 2  $\frac{1}{2}$ " molded top painted white. The east baseboard appears older than the south and west baseboards; there is no visible baseboard on the north wall, which is covered by the closet casework.

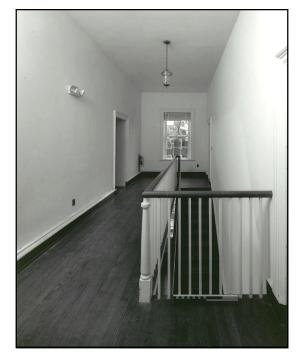
Room 204, Second Floor Hallway

*Ceiling:* The ceiling is plaster on wood lath with evidence of cracking near the east wall.

*Walls:* The walls are made of plaster on brick except for the north wall which is plaster on wood lath. The east and west walls appear to be deflecting slightly at the top in the east-west direction.

*Baseboards:* The 9" baseboards [Type B-16] consist of a 6" vertical face painted black with a 3" molded top painted white and a 1 ¼" squared floor molding. There is severe cracking between trim and wall on the east and south walls.

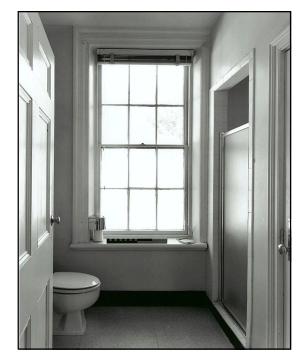
Room 204 A, Second Floor Hall Bathroom

*Floor:* The floor is covered by 12"-square vinyl tiles.

*Ceiling*: The present gypsum board ceiling has been set at the height of the window architraves, lower than the original ceiling.

*Walls:* The north wall is painted plaster on brick. The south and shower/closet walls are plaster and paint on lath attached to wood studs; the west wall is plaster on brick with tile applied to a height of 3'-7" above the floor. The shower opening is edged with tile.

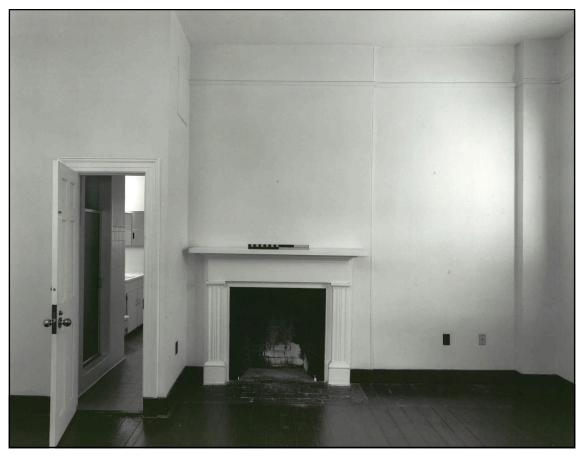
Northwest Guest Room 205

*Floor:* The stained and varnished floor consists of random-width,  $4 \frac{1}{2}$ " to  $5 \frac{1}{2}$ ", tongue-and-groove boards

running north-south. The area to the west of the fireplace shows evidence of piecing, probably due to installation of a bathroom.

*Walls:* The north, east and west walls consist of plaster and paint on brick. The south wall is painted plaster on wood lath. The bathroom walls which protrude into the space are faced with gypsum wallboard. The west portion of the south wall is set back about 2" at a bead molding on the west edge of the chimney mass. A 4" projection at the room's southwest corner appears to be related to the attic chimney attendant to the fireplace in Room 113.

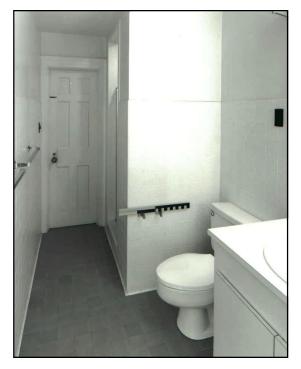
Shared Bath Room, 206 B

*Floor:* The floor is covered with 4  $\frac{1}{4}$  square ceramic tile.

*Ceiling*: The lowered ceiling consists of gypsum wallboard with the insertion of a lighting and ventilation equipment.

*Walls:* The walls are gypsum wallboard except for the east wall which is made of plastered brick. The walls are covered with 4  $\frac{1}{4}$ " square tiles to a height of 5'-1  $\frac{3}{4}$ " above the floor. The shower stall walls are completely tiled.
